Examples show how FACE works ...

FEDERALLY
ASSISTED
CODE
ENFORCEMENT

Department of Public Works • City & County of San Francisco

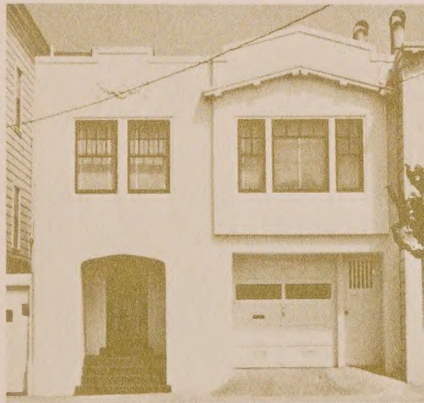
Forty-five year old home with low repair costs

This six-room Richmond District home was well built and maintained. A few code deficiencies were found and corrected with a \$565.00 rehabilitation loan from FACE. A new garage door replaced a dilapidated old one and an electrical branch circuit and additional outlets replaced substandard wiring. The original wiring was no longer adequate to meet the demand of numerous electrical appliances used in this home today.

In addition, the owner repaired a small area of deteriorated decking by himself.

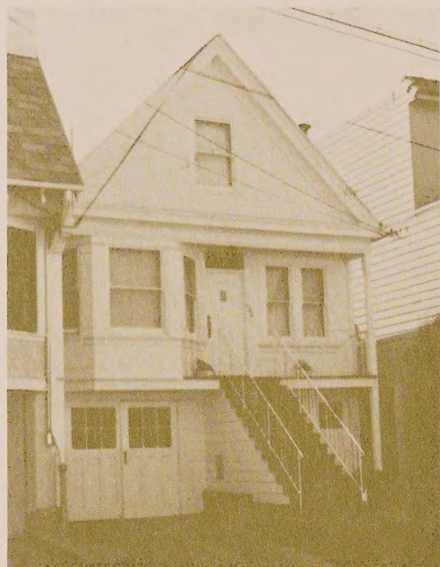
Rehabilitation grant plus \$900 loan restores aging home

The owner, a pensioned widow, received a \$3,500 grant as well as the loan to finance her work. Two coats of paint, new front stairs and railing and new aluminum windows and back porch roof give the exterior a fresh look. Also the back yard was improved by removing a dilapidated old shed.

Interior improvements emphasized safety. The central girder in the basement was supported on rotting posts. New posts and piers were installed. Side

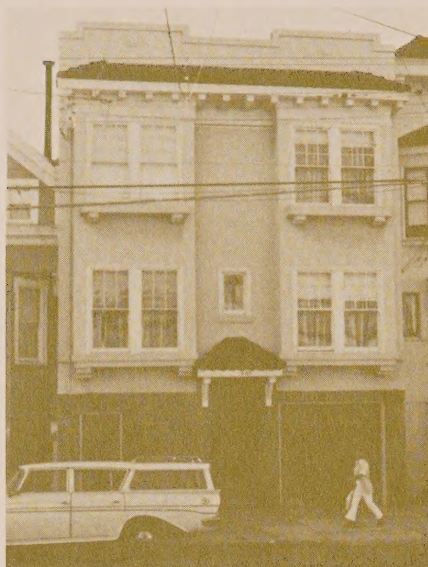
Four unit apartment gets new kitchen sinks

New sinks and cabinets with formica tops were the major improvements made to this building dating from 1916. Sprinklers were installed in the basement storage area, lights were placed in the fire exit passageway in the basement, the plaster ceiling in the basement was repaired and the fire ladder to the roof was replaced.

Total cost was \$2,200 or \$550 per unit. A FACE rehabilitation loan financed the work.

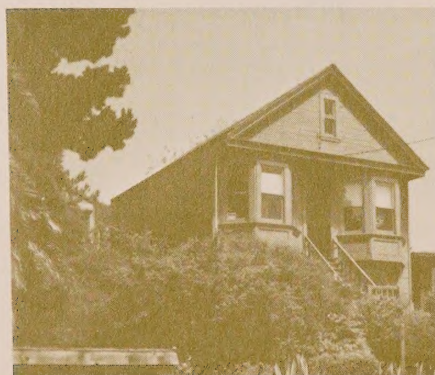
Complete transformation of hillside house

This house had crumbling retaining walls and an unsafe carport which were removed or replaced. In addition the front stairs and rear porch were replaced. Most noticeable is the new shingle siding and the living room addition. A handsome new front door and light fixture add a distinctive touch to the house. All the old windows were replaced.

The inside of the house was painted throughout and wall patching was done.

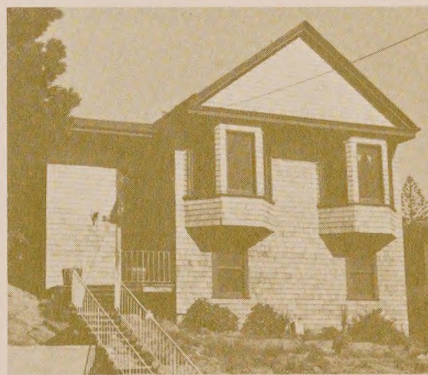
A new heating system was installed, and minor plumbing corrections were made. Beneath the house 66 lineal feet of concrete foundation was built and the ground was covered with concrete rat proofing.

The owners received a FACE loan for \$17,000 to finance the work. As owner occupants they were able to use \$4,600 of this for improvements not required for code compliance.

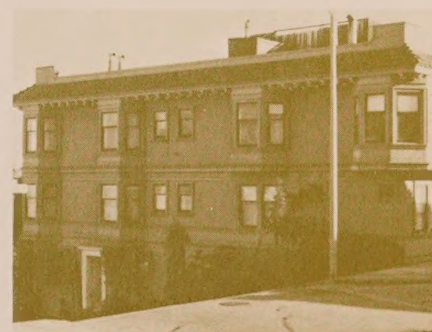
Refinancing permits extensive rehabilitation and lower monthly payments

This owner occupied four unit building had several large mortgages. The payments on these plus the payments on the rehabilitation loan exceeded 20% of the owner's income, making her eligible for 20-year refinancing at 3%. Now her payments are \$48.00 below what she paid before and her building has had \$19,000 in improvements.

The repainted front and rear, new front doors and fire escape and the 14 broken windows which were replaced are the obvious changes. All the old wood windows were put into operating order and two in back were replaced with aluminum ones. New foundations were placed under the three-story back porch structure, and sidewalk repairs, step replacements, handrails, and pent-house repairs complete the list of external improvements.

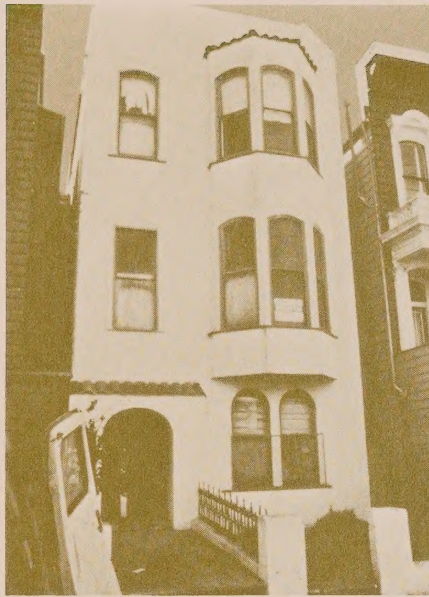
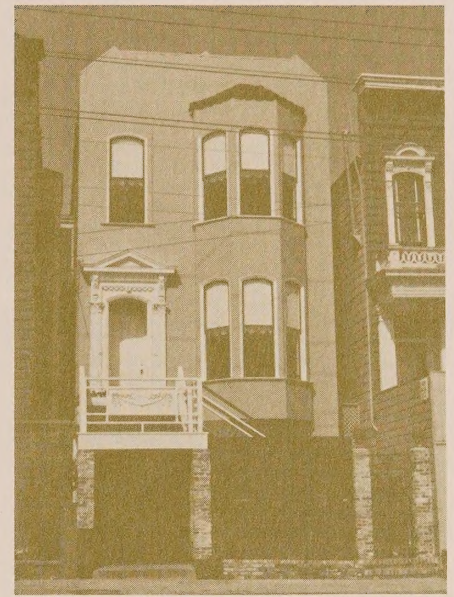
Abandoned 90 year-old apartment gets artistic restoration

Water Department records indicate this three unit building was first served in 1876. Sometime in the 1930's or 40's it was remodeled, losing its Victorian decor in favor of Spanish stucco and tile. The new owner has recaptured some of its early stateliness by adding a Victorian door frame taken from a building being demolished elsewhere.

The building sat vacant several years before the owner-contractor began the restoration with a \$24,600 loan. Fires had rendered the place unlivable, but the structural shell was sound. The re-

habilitation work included all new water piping, water heaters, drainage, gas lines, electricity, heat, totally remodeled kitchens and baths, replacement of almost all wall surfaces, repainting inside and out, lowered ceilings in two units, carpeting throughout all rooms except kitchens and baths, fire proofing of the lobby and provision of a fire extinguisher, repair and replacement of all broken and unfunctioning windows and construction of new front and rear stairs.

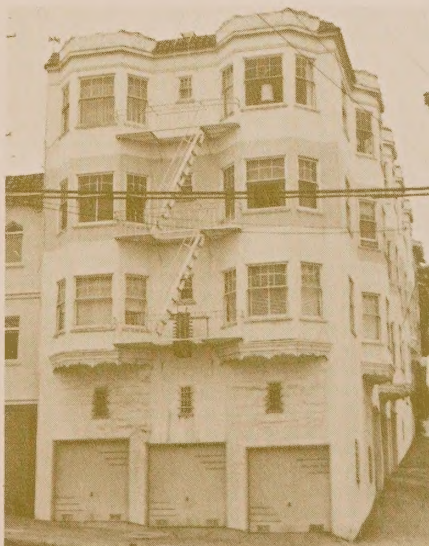
Forty years old and in excellent condition

This 12 unit building needed only \$200 worth of work, which attests to fine management and maintenance practices. A sprinkler at the bottom of the garbage chute was the only costly item, but other important though low cost corrections were made. The fire extinguisher needed recharging. A tree blocking a fire escape needed trimming. Had there been a fire these minor corrections could have been critical factors in saving lives or minimizing fire damage.

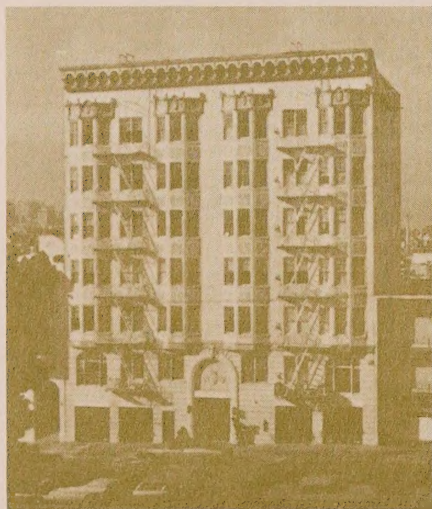
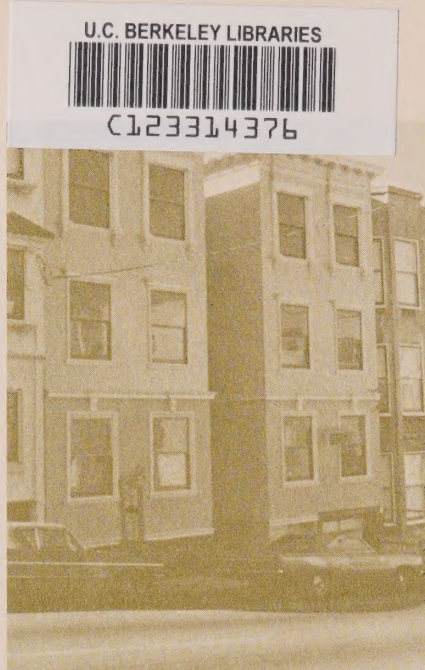
Tenants remain in building during construction

This 12 unit building had extensive work, \$4,000 worth per unit. There were six vacancies by the time the work was to start and this enabled relocating the tenants within the building as apartments were rehabilitated.

The work included new kitchens, with modern stoves and refrigerators throughout the building. Half of the baths were replaced and all were tiled and had tub enclosures installed. Most were given new washbasins and several new toilets were installed. Plaster was patched throughout the building, half the apartments were repainted and the halls and lobby were recarpeted and repainted. All the hardwood floors were refinished. All windows were repaired and made operable; some had been painted shut for years. Miscellaneous electrical repairs were made. Storage areas were sprinklered and fire extinguishers were provided. About 40 feet of foundation was raised across the rear where walls had rotted from contact with the ground.

Outside improvements included repainting after repairing and renailling the siding and trim. Fire escapes were repaired, and deteriorated stairs in the light wells were replaced with fire ladders. Old broken down fences and garbage chutes were replaced. Rubbish and debris was removed from the yards and basement. A new garage door was installed.

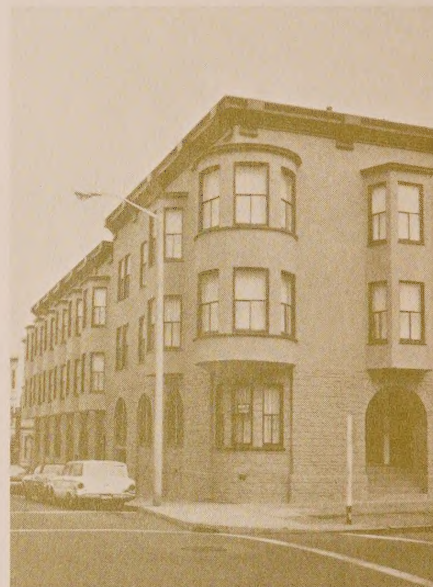
Total rehabilitation at \$10,000 per unit

This 15-unit building was in deplorable condition. Three of its units were uninhabitable because of extensive water damage to plaster. The back stairways were hazardously deteriorated and rotting plank floors in the basement were covered with debris.

The building's appearance was greatly improved through FACE. The exterior was repainted and a new roof was put on. All windows were replaced and those on the ground floor had protective ornamental grilles applied. The stairs were replaced along with some decking, fences and 45 feet of retaining wall. Garbage chutes were added.

Interiors were totally redone. New kitchens and baths with all the amenities were provided. All plaster walls were repaired or replaced, sprayed acoustical ceilings were put in, and all rooms were repainted. Hardwood floors were refinished and halls were carpeted. Doors and locks were replaced throughout and an entrance intercom system was provided. New light fixtures were installed as well as additional utility circuits and outlets in all kitchens and some other rooms. Water and gas piping was replaced, and a new central water heating system was put in. The steam heat system was rehabilitated and a new coin-op laundry room replaced laundry trays. The basement was ratproofed.
